Home Inspection Report

123 Example Lane, Example, IL 60189

Friday, July 22, 2016

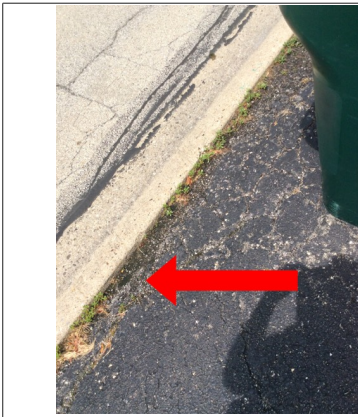
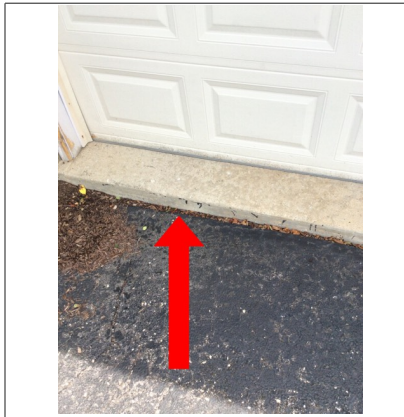
Comments Trip hazard in driveway, recommend repair and/or replacement

Trip Hazard

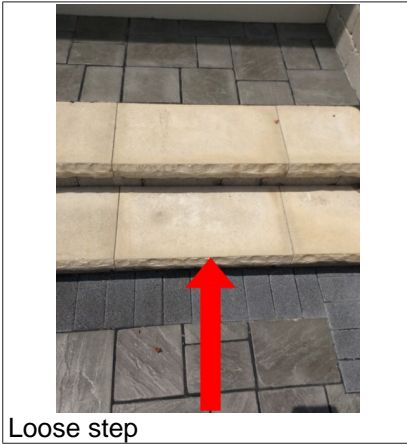
Material ☒ Brick
Condition ☒ Marginal ☒ Trip hazard
Comments Recommend securing step

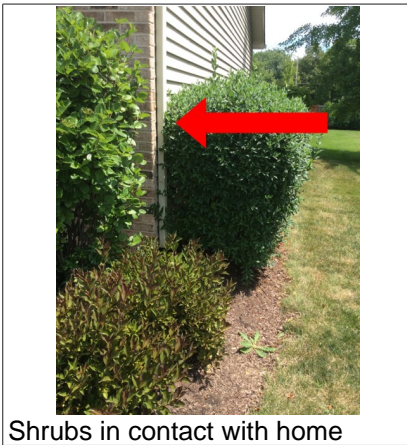
**Deck/Patio/Porch Covers****Condition** ☒ Satisfactory**Recommend** ☒ None**Fence/Wall****Type** ☒ Wood**Condition** ☒ Satisfactory**Gate** ☒ Satisfactory **Operable:** ☒ Yes**Landscaping affecting foundation****Negative Grade** ☒ Satisfactory ☒ Trim back trees/shrubberies**Comments** Recommend trimming trees/vegetation so it does not come into contact with the home**Photos**

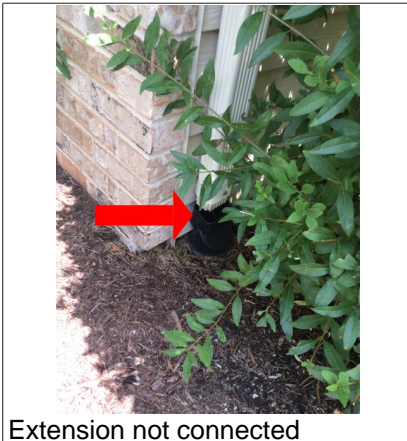
Extension not connected

Comments Recommend Repairing downspout extensions to discharge away from the house. 5-6' extensions recommended.

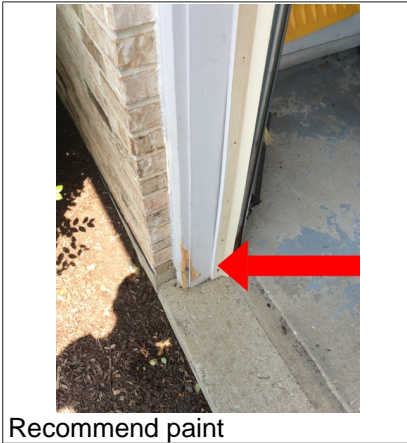
Comments Trim was in need of normal painting maintenance.

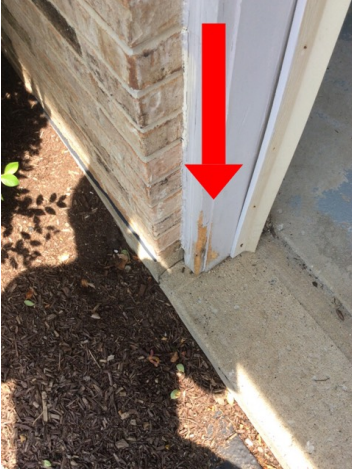
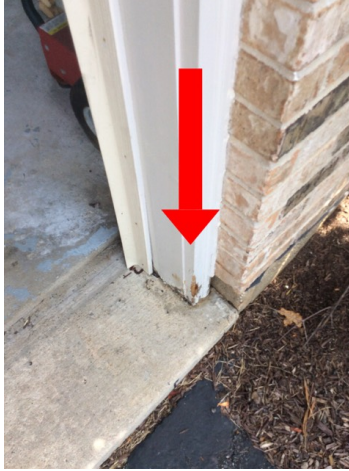
Recommend repair/paint

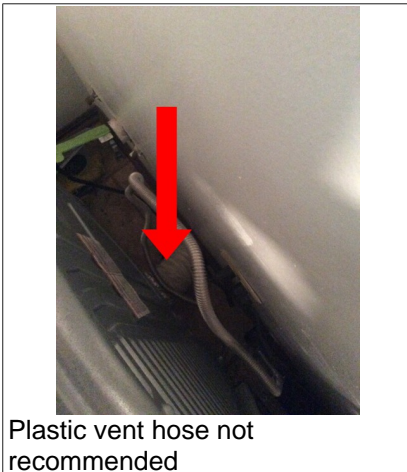
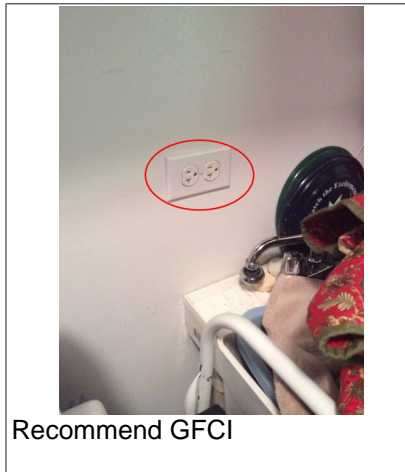
Comments Missing GFCI Outlet For Enhanced Safety Recommended Qualified Electrician Replace

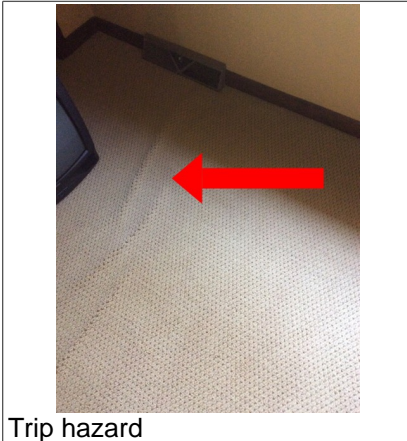
Trip hazard

Trip Hazard, Recommend Carpet Re-stretched By Qualified Professional

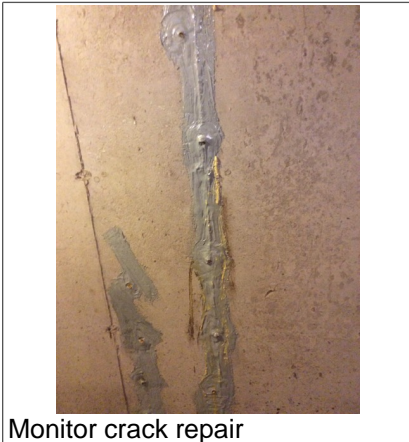
Comments Recommend monitoring patched crack in basement wall

Monitor crack repair

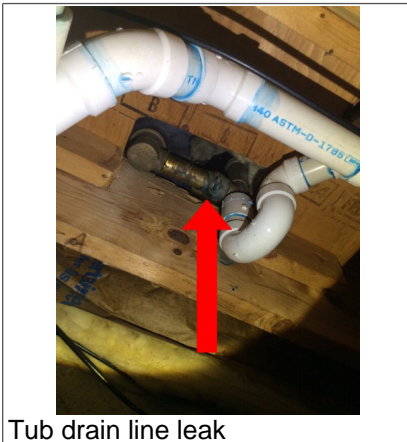
Comments Drain pipes are leaking - Recommend licensed plumber repair

Tub drain line leak

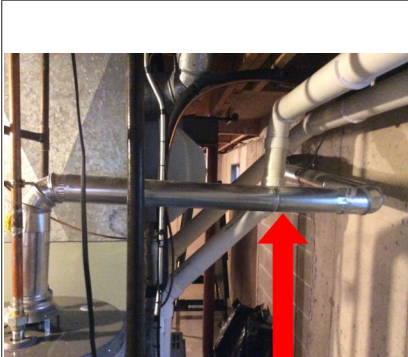
Comments Vent pipe is pitched improperly - needs to slope up towards the chimney - recommend qualified contractor repair

Improper pitch, missing hangers, safety issue

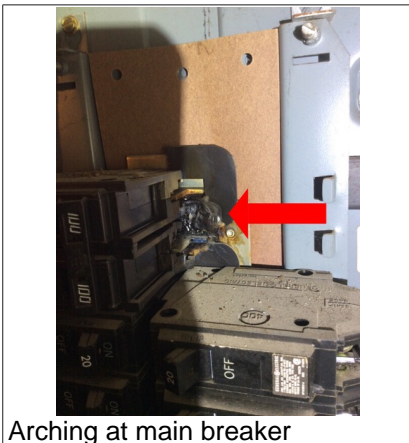
Comments Main breaker showed signs of overheating recommend a qualified electrical contractor evaluate and repair

Arching at main breaker
