Home Inspection Report

123 Example Lane, Example, IL 60189

Friday, July 22, 2016

Home Pulse Pro LLC.
808 Benson Ct
North Aurora, IL 60542
331-256-5505

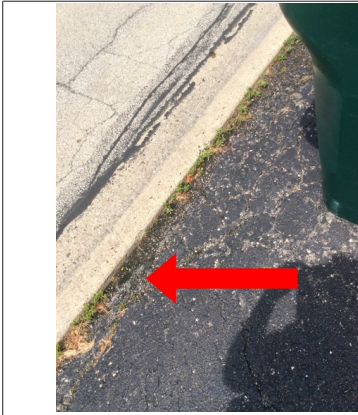
Trip hazard in driveway, recommend repair and/or replacement

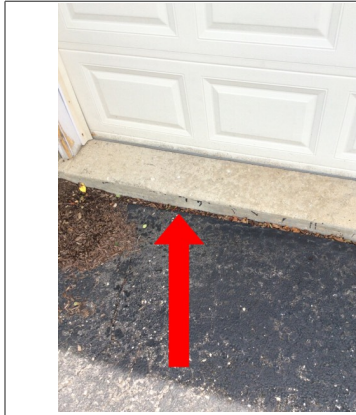
Trip hazard in driveway, recommend repair and/or replacement

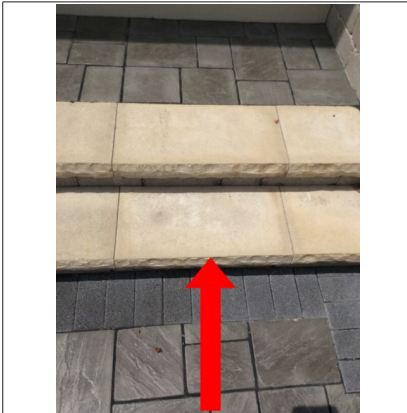
Back stoop had loose brick on step, safety hazard, Recommend securing loose brick

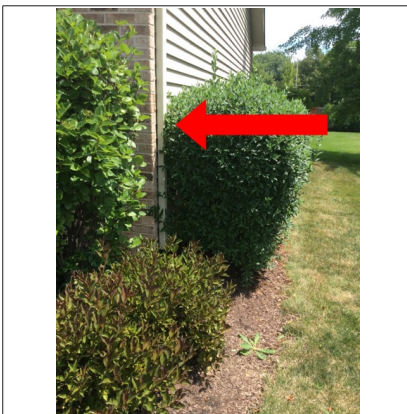
Recommend trimming trees/vegetation so it does not come into contact with the home

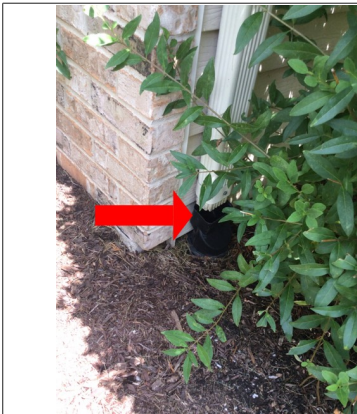
Extension not connected,
Recommend Repairing
downspout extensions to
discharge away from the house.
5-6'.

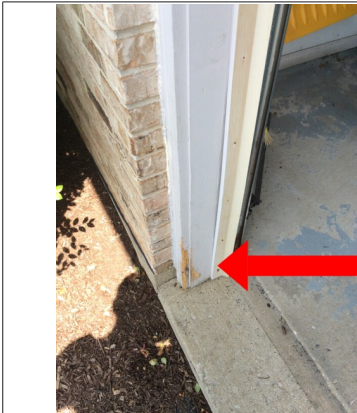
Trim was in need of normal painting maintenance.

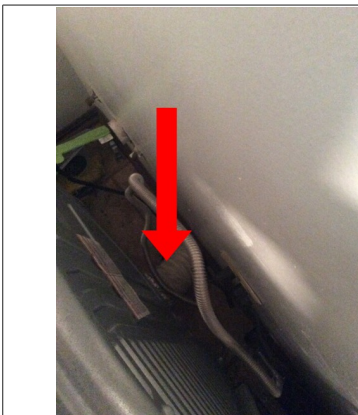
Plastic vent hose not recommended for gas dryer, potential fire hazard.

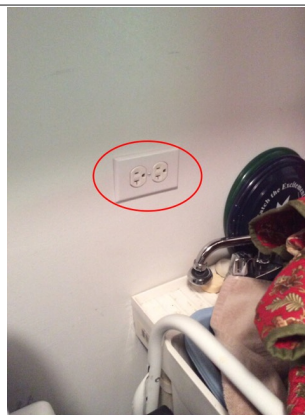
Recommend GFCI

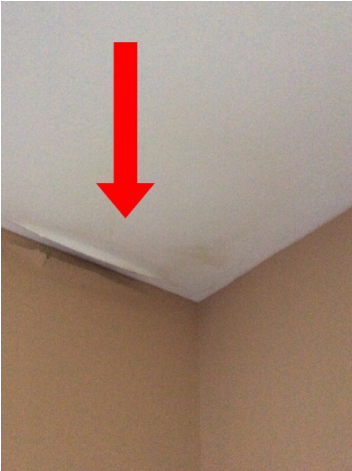
Bedroom 2 Photos

Holes in wall/ceiling caused by previously repaired water damage, recommend repair/paint

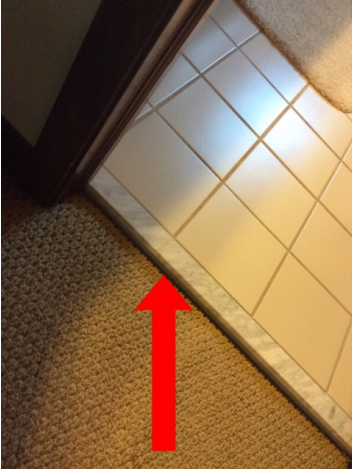
Bathroom 1 Photos

Trip hazard at Bathroom entry,
recommend repair/replace transition

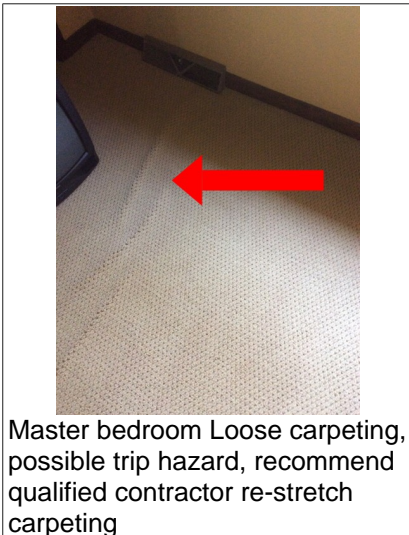
Comments Master bedroom Loose carpeting, possible trip hazard, recommend qualified contractor re-stretch carpeting

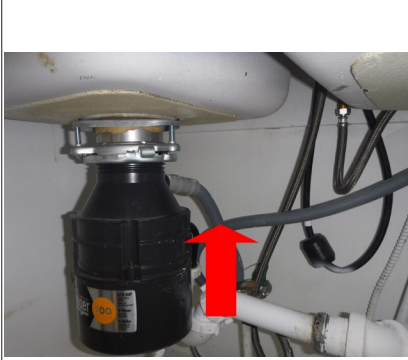
Dishwasher drain line not looped beneath countertop. Recommend repair

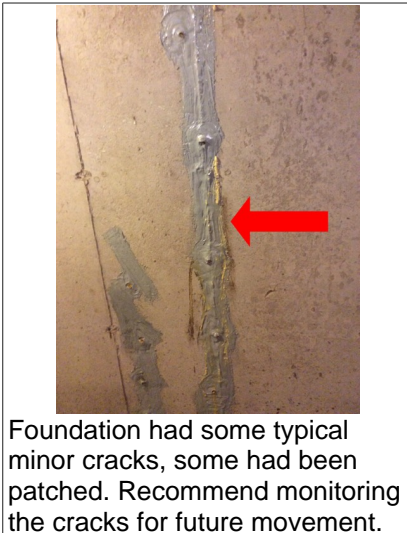
Comments Foundation had some typical minor cracks, some had been patched. Recommend monitoring the cracks for future movement.

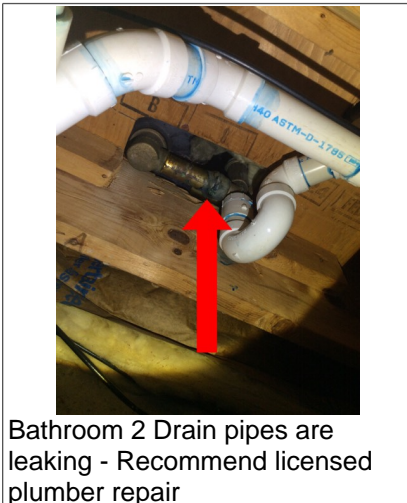
Comments Bathroom 2 Drain pipes are leaking - Recommend licensed plumber repair

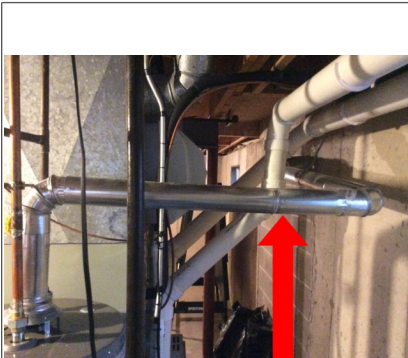
Vent pipe is pitched improperly - needs to slope up towards the chimney - recommend qualified contractor repair

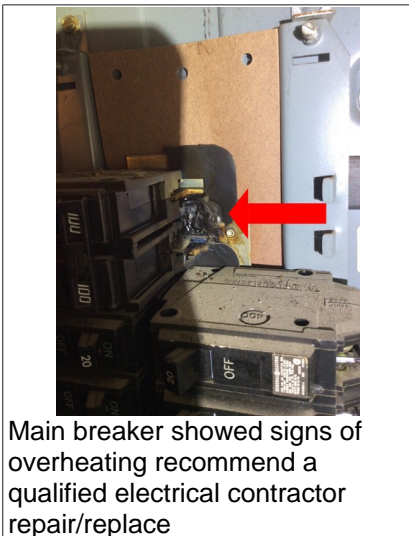
Comments Main breaker showed signs of overheating recommend a qualified electrical contractor repair/replace
